AEROSPACE RECOMMENDED PRACTICE

ARP6307™**REV. A**

New and Newly Retreaded Tire Appearance

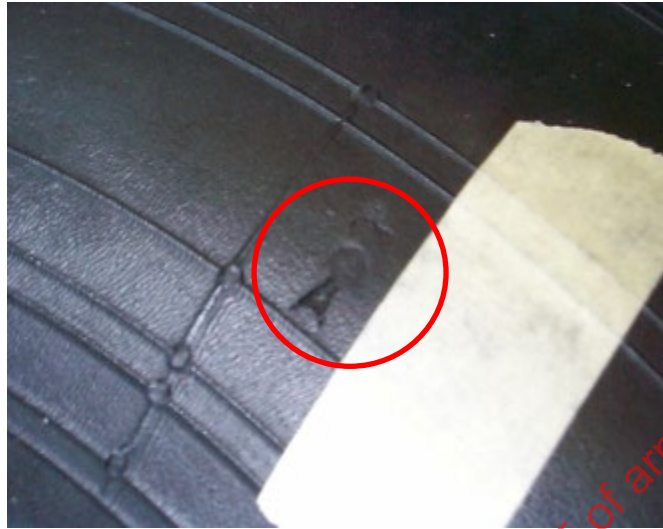
Figure 1

Impressions on the tire can be due to the tire being in contact with a foreign object for a long period of time during storage or shipping.

Impression example - This tire is acceptable for use.

- The tire is acceptable for use provided the impression is not on the wheel interface.

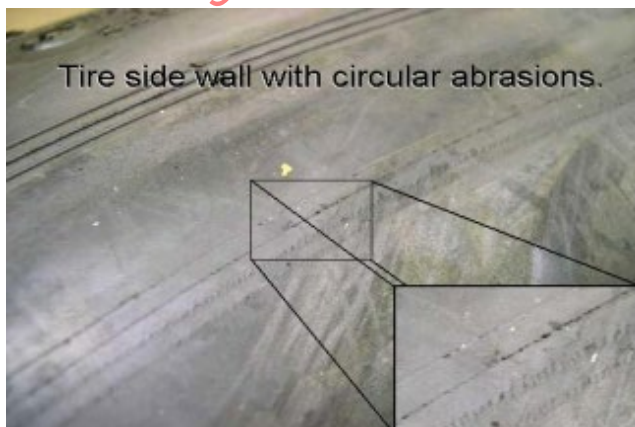
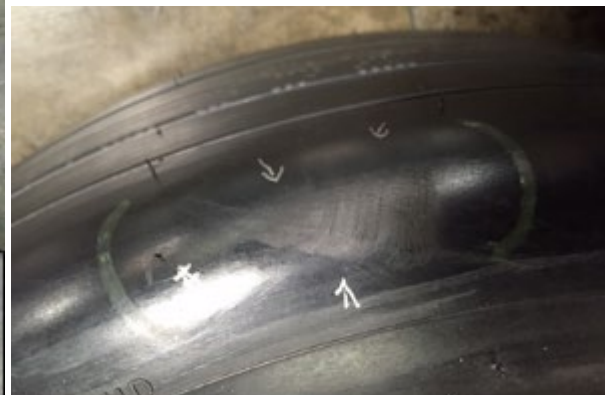
Abrasions on the tire can be attributed to tires rubbing against each other, the shipping container wall, or storage facilities floor/walls.

Abrasion examples - These tires are acceptable for use.

- Tire is acceptable for use provided fabric reinforcements are not visible and providing the required tire identification markings (load/speed ratings, part number, serial number, ply rating, (E)TSO-C62 marking, etc.) are still clearly legible.

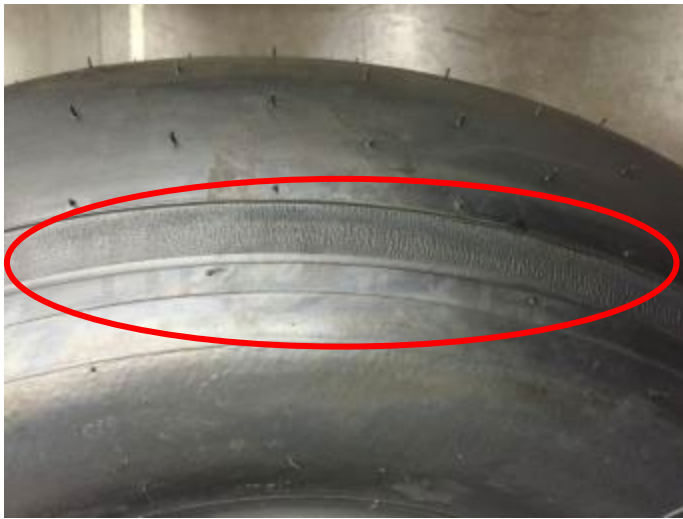
Figure 4

- A rough surface finish on the shoulder of the tire just below the new tread rubber caused by buffing during the retreading process.
- An abraded/cracked surface on the lower sidewall caused by contact with the wheel flanges in previous usage.

Tread buffed surface example - Tire acceptable for use.

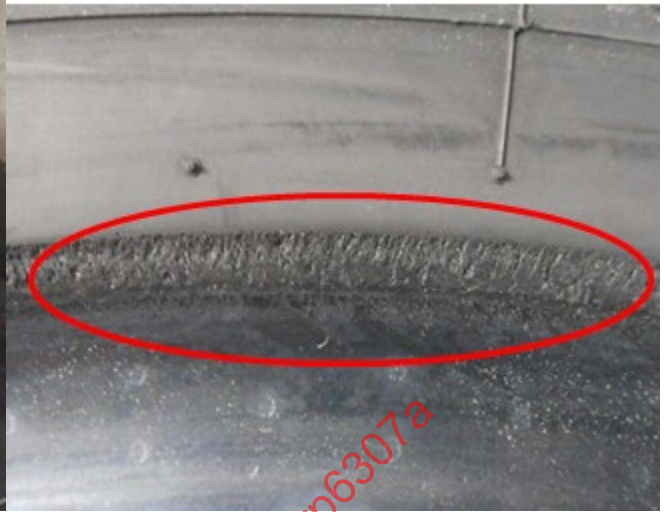
Figure 5

Lower sidewall abrasion example - Tire acceptable for use.

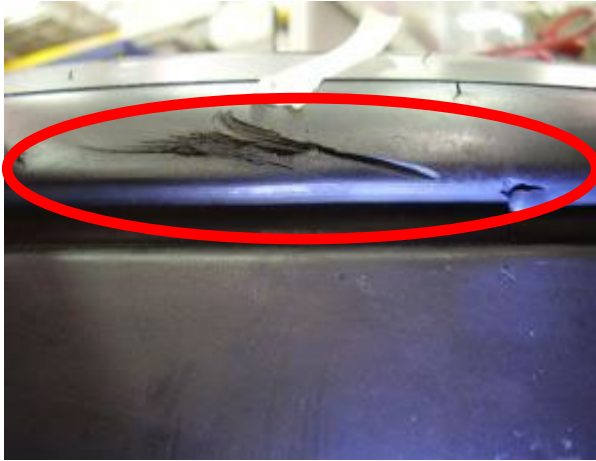
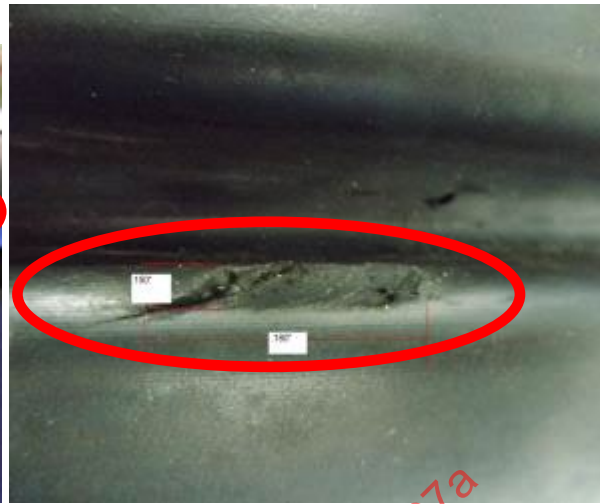
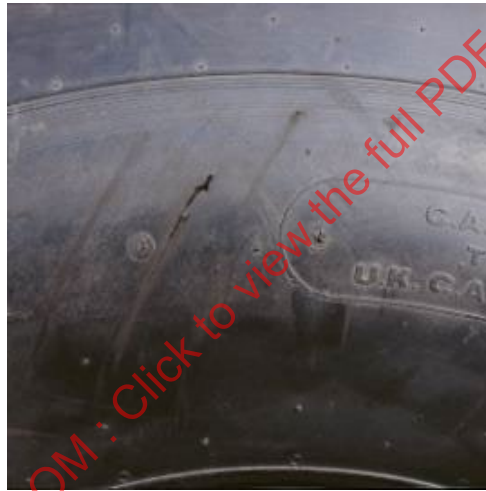
- Sharp objects contacting the tire during shipping or storage.
- Improper use of fork lifts to maneuver the tire during shipping or storage.

Cut examples - Figures 6, 7, and 8 - These tires should not be used.

- Shallow scratches that do not penetrate the tire surface are acceptable. If cuts penetrate the tire, do not use tire.

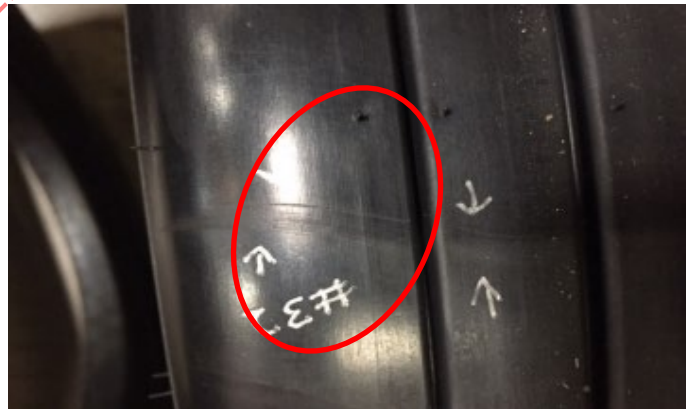
**Figure 9**

Superficial scratch example - This tire may be used.

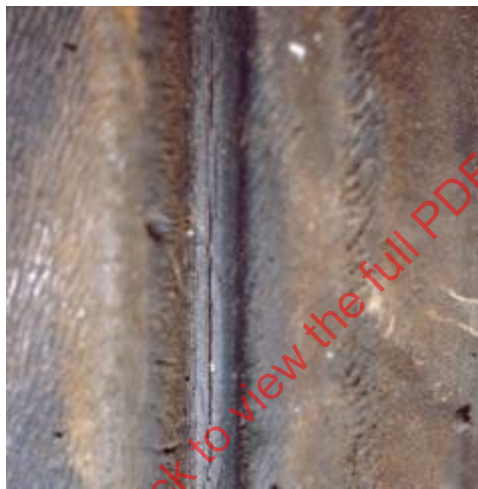
Figure 10

Cracks may be caused by the molding process and improper storage (ozone attack).

Crack example - This tire is acceptable for use (photo is of a used tire).

- Tire is acceptable for use unless the fabric reinforcements are exposed.

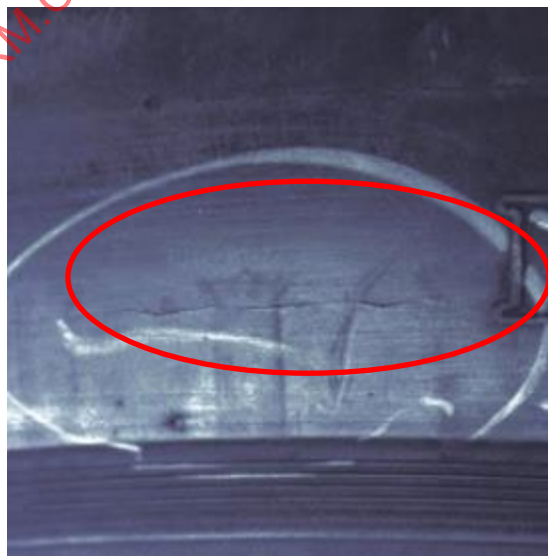
Figure 11

Crack example - This tire may be used.

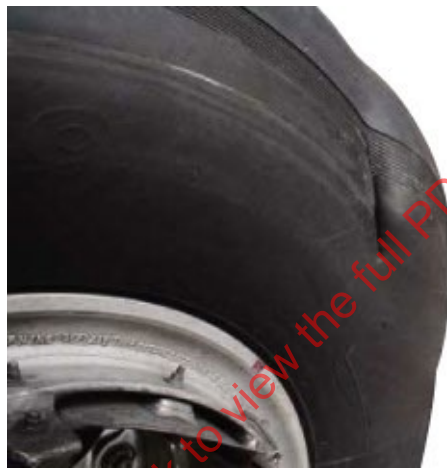
Figure 12

Bulges on the tire may occur as a result of chemical contamination or curing issue.

Bulge in tread example - This tire should not be used.

- Do not use.

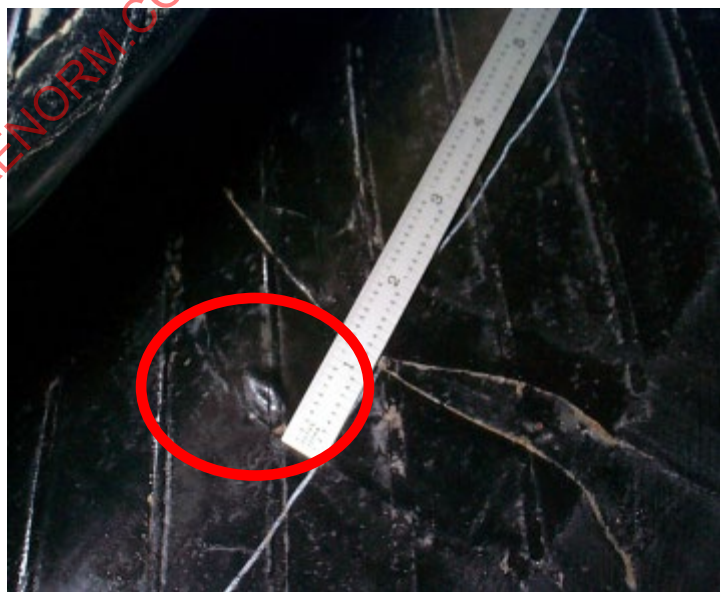
Figure 13

Bubble in liner example - This tire should not be used.

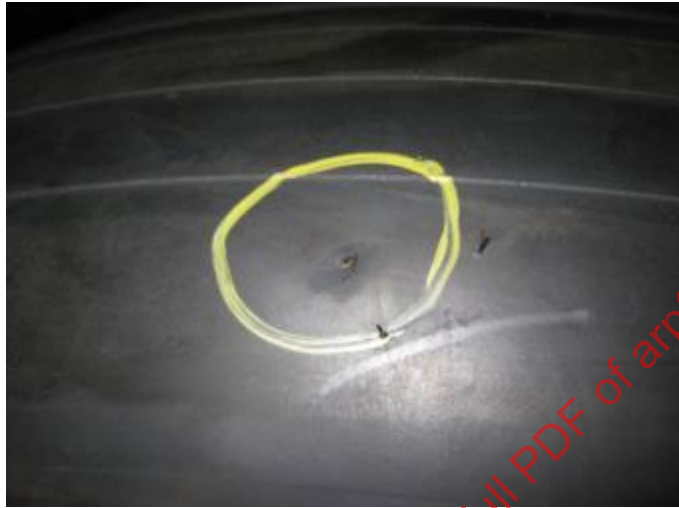
Figure 14

Tire punctures can be caused by a foreign object or mishandling during shipping or storage.

Puncture example - This tire should not be used.

- Do not use tire.

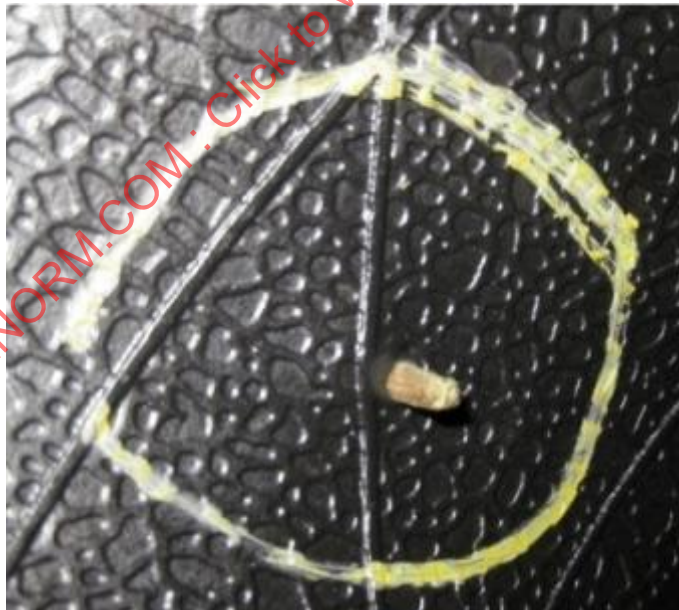
Figure 15

Puncture example - This tire should not be used.

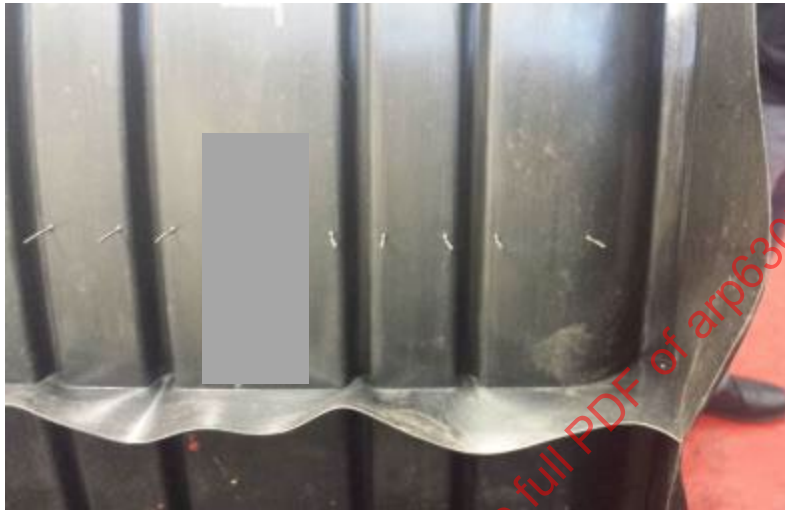
Figure 16

Excessive flash is due to the molding process which was not removed and missed during inspection.

Flash example - This tire should not be used.

- Tire is acceptable provided the flash trimming is not in the wheel interface area or does not exceed 5 mm tall x 100 mm long (0.2 inch tall x 4 inches long).

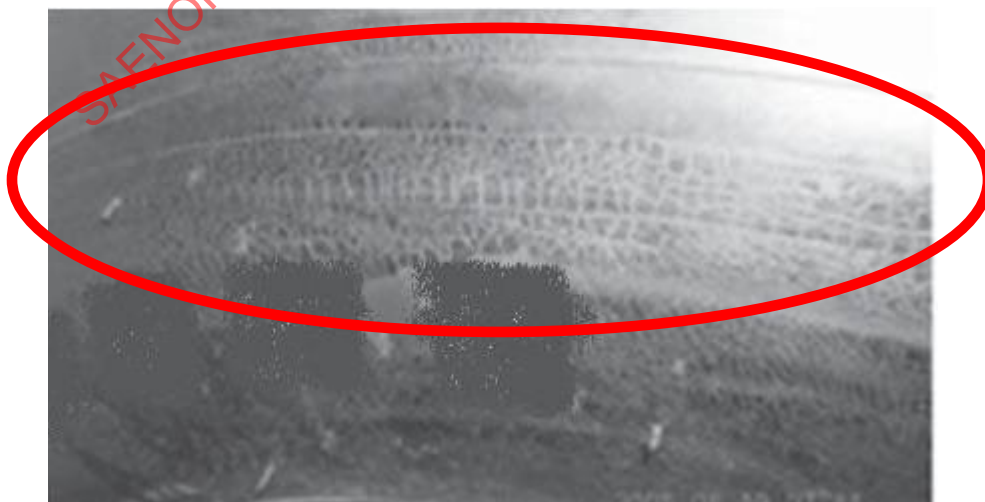
Figure 17

Precure paint is used during the molding process to prevent the tire from sticking to the mold.

Precure paint example - This tire is acceptable for use.

- Tire is acceptable for use.

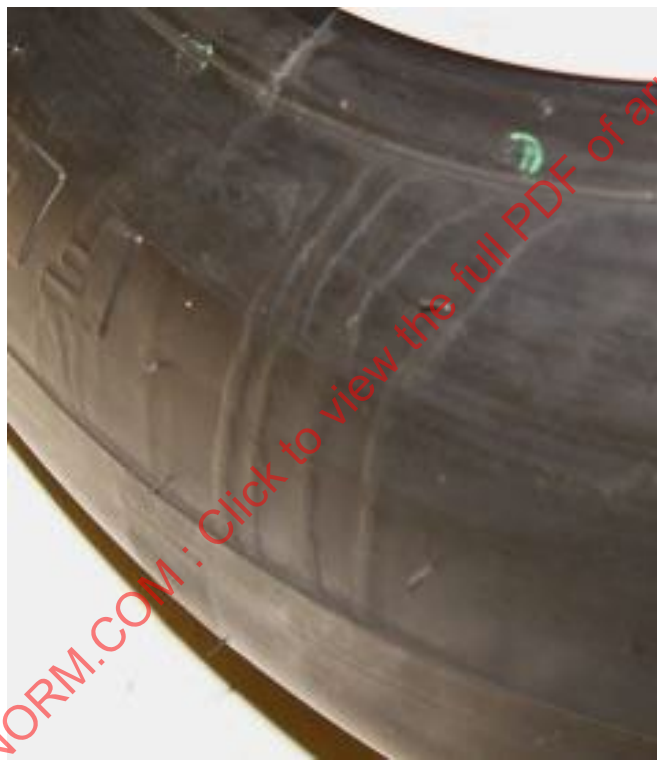
Figure 18

Contamination example - This tire should not be used.

In case of contamination, check for rubber condition. The tire has to be cleaned quickly with denatured alcohol to remove the contaminant then washed with a soap and water solution. Ensure that the contaminated rubber surface has not swelled. An easy check is to push your finger nail into the contaminated surface, and, in case of swelling, the nail will leave a permanent imprint. If the rubber has swelled, do not use the tire.
