AEROSPACE RECOMMENDED PRACTICE

ARP6225

Aircraft Tire Inspection - In-Service Removal Criteria

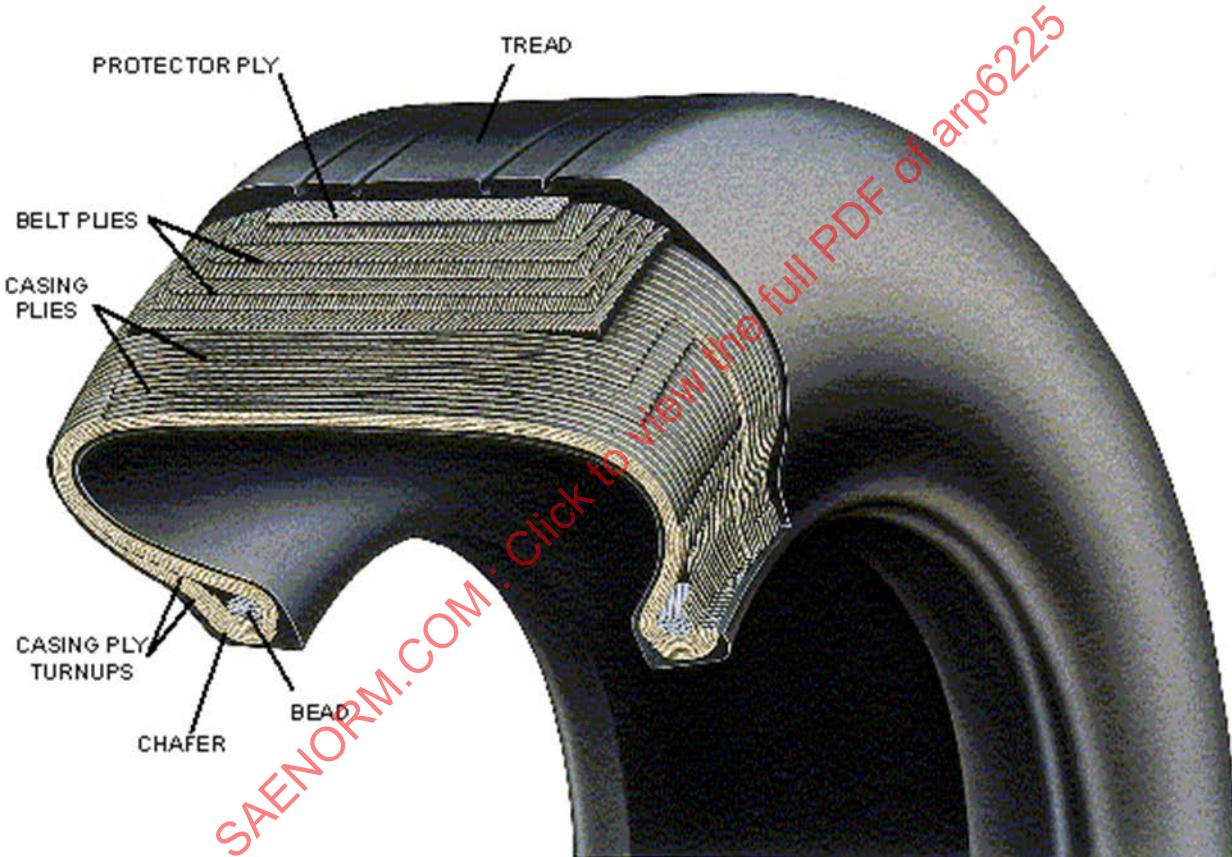
FIGURE 1 - RADIAL TIRE COMPONENTS NOMENCLATURE

The radial and bias tire components are shown in Figures 1 and 2. Due to design parameters, the actual tire may or may not contain all pictured components.

RADIAL AIRCRAFT TIRE CONSTRUCTION

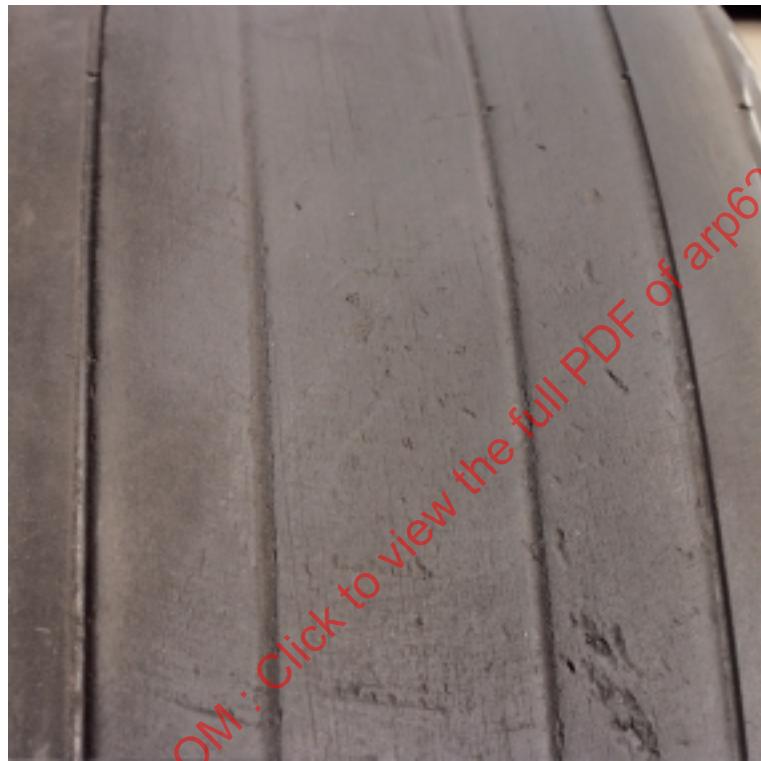
FIGURE 3 - NORMAL WEAR

An even tread wear indicates that the tire has been properly maintained during its service life.

NORMAL REMOVAL WEAR LIMIT: When the wear level reaches the bottom of any groove at one point or up to 1/8 of the circumference (Figure 3):

NOTE: When the NORMAL REMOVAL limit is reached, the tire should be replaced. If it is necessary to continue the tire in service beyond the normal wear limit, the tire should be removed either at the next maintenance base or upon reaching the RETURN TO BASE WEAR LIMIT, whichever occurs first. At the RETURN TO BASE LIMIT, the tire should be removed and replaced. In such a case however, the subject tire might not be suitable for retreading.

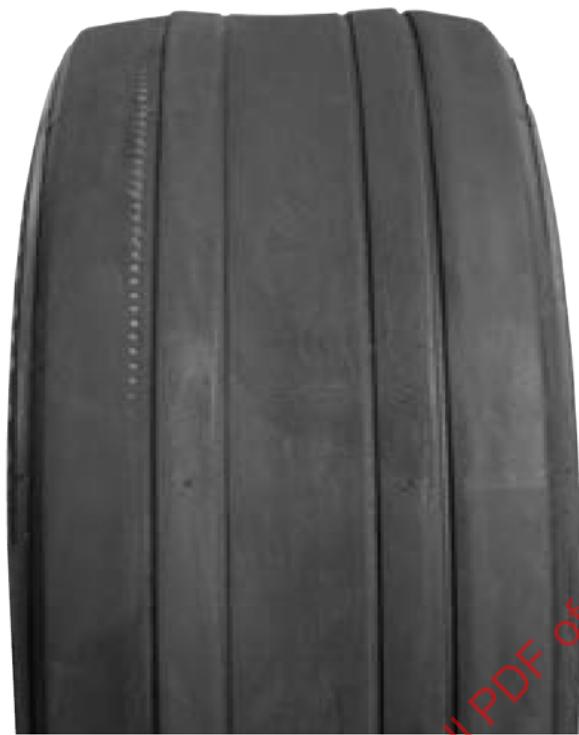
FIGURE 4 - SHOULDER WEAR

Under-inflation can lead to excessive tread shoulder wear. It will lead to high tire deflection and subsequent heat build-up which may result in severe tire damage. The cause for operating underinflated should be investigated by the operator and corrective actions taken.

REMOVAL LIMIT: Tires with uneven wear should be removed from the aircraft if the wear limits (defined under normal wear) are reached.

RETURN TO BASE WEAR LIMIT: If either the protector ply (radial) or the reinforcing ply (bias) is exposed at any location over the tread surface (Figure 4 or 5).

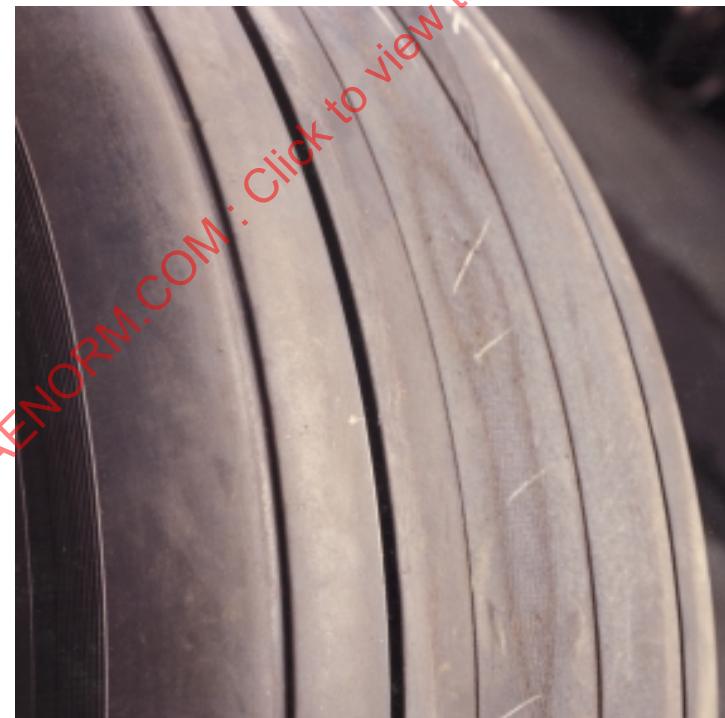
FIGURE 5 - CENTER WEAR

Over-inflation can accelerate the center tread wear, reduce tire traction, reduce the number of landings per tread and make the tire more susceptible to cutting and foreign object damage (FOD).

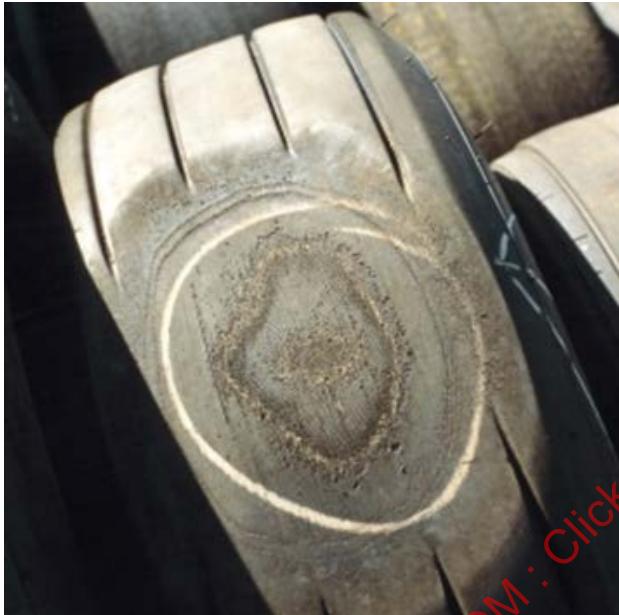
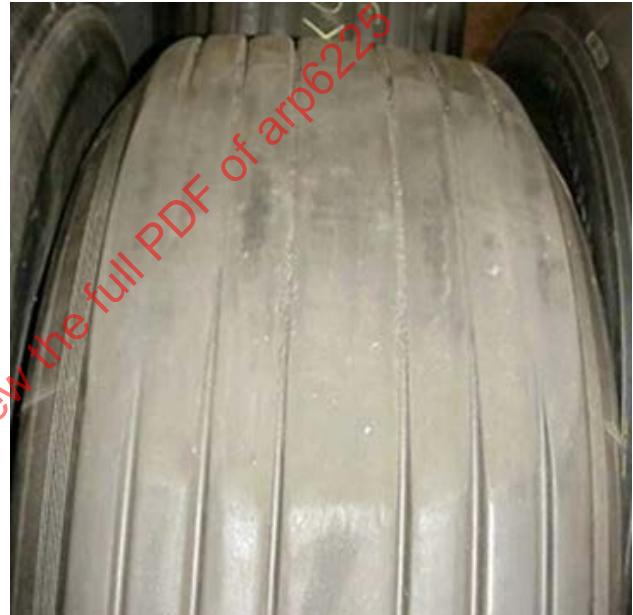
FIGURE 7 - FLAT SPOT

Tread flat spot or severe tread rubber abrasion results from steering maneuvers prior to aircraft rolling, or the locking of the wheel during braking or touchdown. Flat spotting due to cold temperature or prolonged parking is not a condition for tire removal.

1. the flat spot damage exceeds the wear removal criteria of 5.1; or
2. the flat spot contributes to an unacceptable vibration condition (Figure 7).

Locked wheel tire flat spot

Typical tire flat spot

NOTE: The tire can remain in service if the flat spot does not reach the above-mentioned limit and if there is:

1. sufficient groove depth in the whole flat spot area;
2. no incipient (visible) separation; and
3. the vibration level is within an acceptable range during rolling.

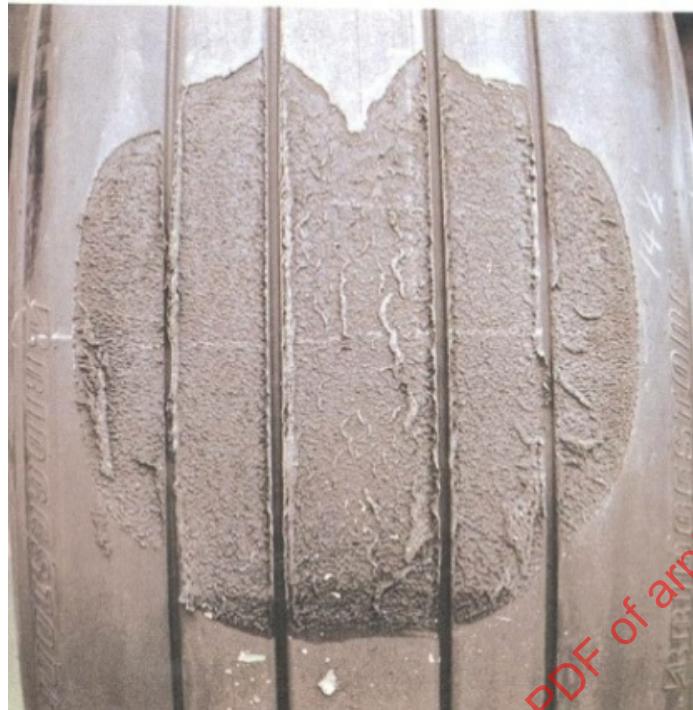
FIGURE 8 - TREAD RUBBER REVERSION

Tread rubber reversion is generally caused by wheel locking on wet or ice covered runways. The affected area is similar in shape to a flat spot (oval), but the rubber appears to be melted (Figure 8).

1. the reversion flat spot damage exceeds the wear removal criteria of 5.1; or
2. an unacceptable vibration condition is experienced.

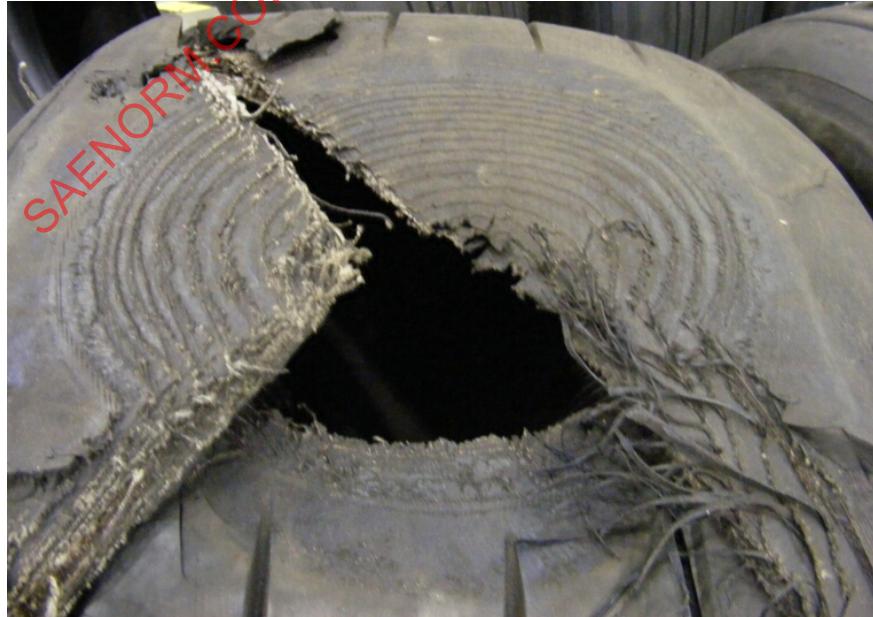
FIGURE 9 - SKID THROUGH

Skid-through burst results from the locking of the wheel. In this case, the tire experiences either a loss of inflation pressure or an explosive blowout (Figure 9).

REMOVAL LIMIT: Both the failed tire and axle mate tire should be removed from the aircraft, the burst tire marked as “scrap” and the axle mate tire marked with the removal reason (“Mate to Flat”). The skid through tire can be scrapped locally but the mate to flat tire should be returned to the tire manufacturer or retreader.

<u>Skid-Through Burst</u>	Skid-through burst results from the locking of the wheel. In this case, the tire experiences either a loss of inflation pressure or an explosive blowout. (Figure 9).	Both the failed tire and axle mate tire should be removed from the aircraft, the burst tire marked as "scrap" and the axle mate tire marked with the removal reason ("Mate to Flat"). The skid through tire can be scrapped locally but the mate to flat tire should be returned to the tire manufacturer or retreader.

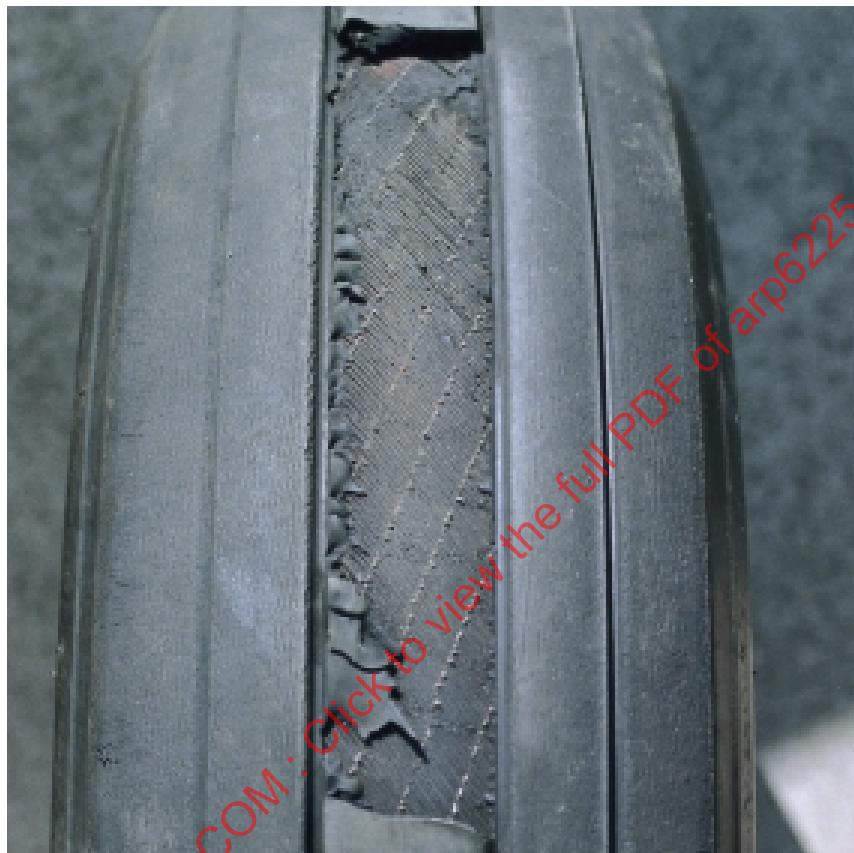
FIGURE 10 - PEELED RIB

A peeled rib usually starts with a cut or damage in the tread and results in a circumferential delamination of the tread rib away from the tire casing, typically with no loss of reinforcing plies (Figure 10) or tire pressure.

REMOVAL LIMIT: The tire should be removed immediately from service when the peeled section, regardless of length, is exposing fabric or has fully detached. Pieces from the tread should be requested from airport authorities and returned to the home base for potential analysis by the tire supplier.

<u>Peeled Rib</u>	A peeled rib usually starts with a cut or damage in the tread and results in a circumferential delamination of the tread rib away from the tire casing, typically with no loss of reinforcing plies (Figure 10) or tire pressure.	The tire should be removed immediately from service when the peeled section, regardless of length, is exposing fabric or has fully detached. Pieces from the tread should be requested from airport authorities and returned to the home base for potential analysis by the tire supplier.
<u>Thrown Tread</u>	A thrown tread on an inflated tire is a partial or complete loss of the tread down to the casing plies or tread reinforcing plies/protector ply (Figure 11).	The tire should be removed immediately from service. Pieces from the tread should be requested from airport authorities and returned to the home base for potential analysis by the tire supplier. If the damaged tire is not inflated due to a loss of inflation pressure, then the axle mate should be removed also. If the tire is still inflated after the aircraft is parked, record the tire pressure after it has cooled down (allow 3 hours).

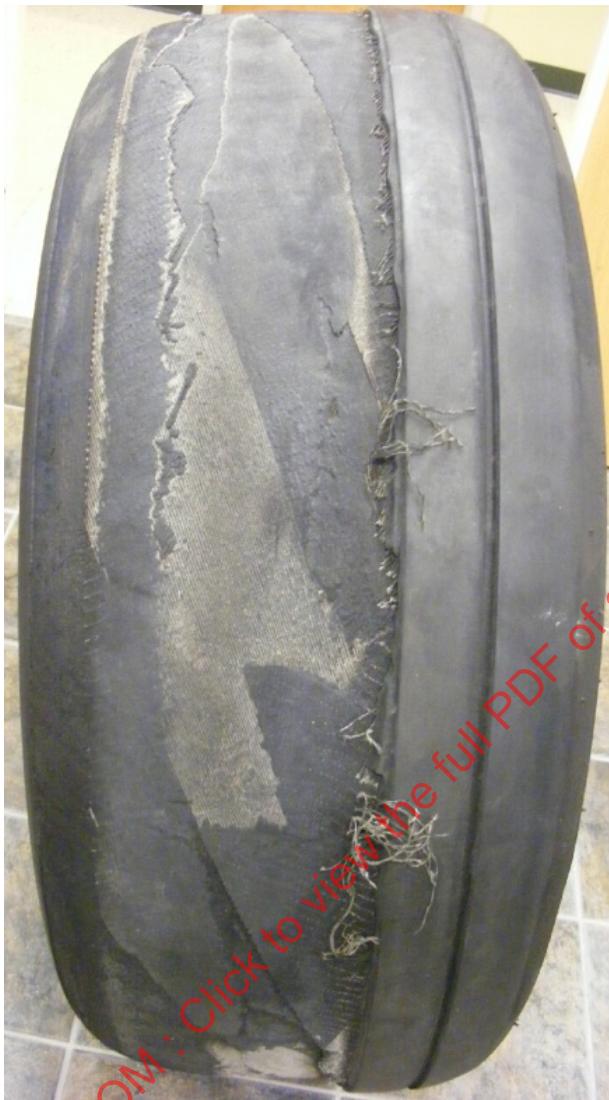
FIGURE 11 - THROWN TREAD

A thrown tread on an inflated tire is a partial or complete loss of the tread down to the casing plies or tread reinforcing plies/protector ply (Figure 11).

REMOVAL LIMIT: The tire should be removed immediately from service. Pieces from the tread should be requested from airport authorities and returned to the home base for potential analysis by the tire supplier. If the damaged tire is not inflated due to a loss of inflation pressure, then the axle mate should be removed also.

If the tire is still inflated after the aircraft is parked, record the tire pressure after it has cooled down (allow 3 hours).

NOTE: Early signs of tread separation can manifest themselves in the form of tread bulges, local uneven wear (depression) or local tread/sidewall rubber split.

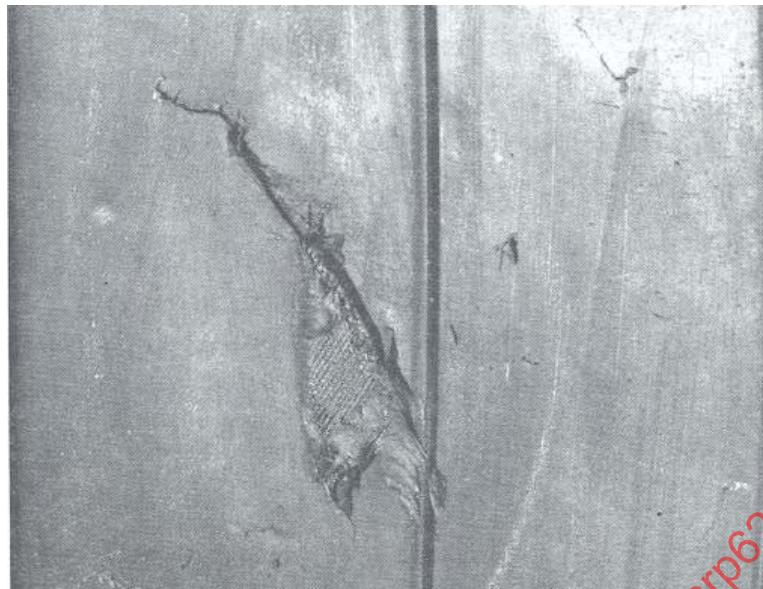
FIGURE 12 - TREAD CUT

Foreign objects that are present on runways, taxiways and parking areas can cause cuts to the tires (Figure 12).

- the cut exposes or penetrates reinforcing ply (bias tire) or protector ply (radial tire), or
- the cut or damage severs or extends across a tread rib, or
- undercutting occurs at the base of any tread rib cut

<u>Tread Cuts</u>	Foreign objects that are present on runways, taxiways and parking areas can cause cuts to the tires (Figure 12).	Tire should be removed immediately from the aircraft if: <ul style="list-style-type: none"> the cut exposes or penetrates reinforcing ply (bias tire) or protector ply (radial tire), or the cut or damage severs or extends across a tread rib, or undercutting occurs at the base of any tread rib cut
<u>Chevron Cutting</u>	Chevron cutting is tread damage (small z-, s- or v-shaped tears) caused by touchdown, running and/or braking on cross-grooved runways (Figure 13). Chevron cutting is a condition of the tread rubber only.	Tire should be removed from aircraft if: <ul style="list-style-type: none"> The tread cut criteria are reached, or The tread reinforcing ply (bias tire) or protector ply (radial tire) is exposed for more than 1.0 square inch (6.45 cm^2), or The cutting involves the full width of any one of the tread ribs

NOTE: Mark all cuts, foreign object damage (FOD), or leak sites while the tire is still inflated. Damage can be difficult to locate when the tire is deflated.

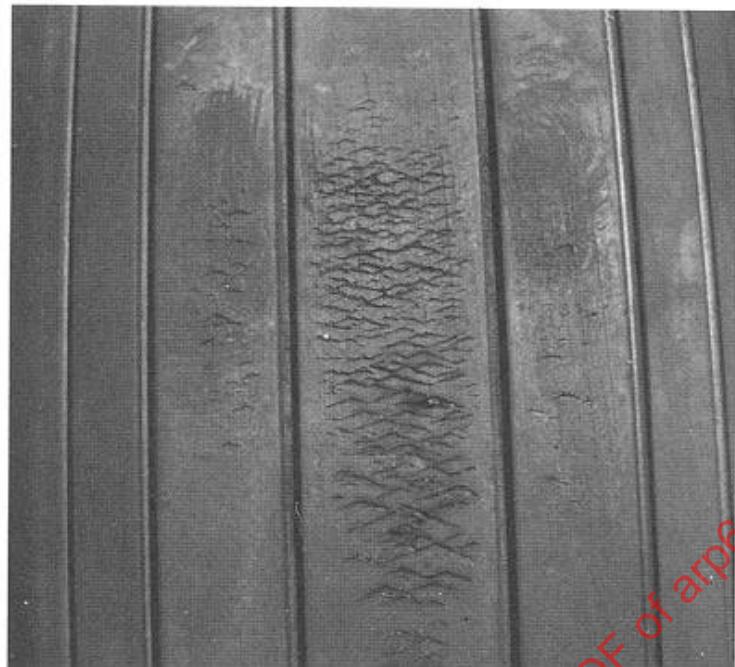
FIGURE 13 - CHEVRON CUTTING

Chevron cutting is tread damage (small z-, s- or v-shaped tears) caused by touchdown, running and/or braking on cross-grooved runways (Figure 13). Chevron cutting is a condition of the tread rubber only.

- The tread cut criteria are reached, or
- The tread reinforcing ply (bias tire) or protector ply (radial tire) is exposed for more than 1.0 square inch (6.45 cm^2), or
- The cutting involves the full width of any one of the tread ribs

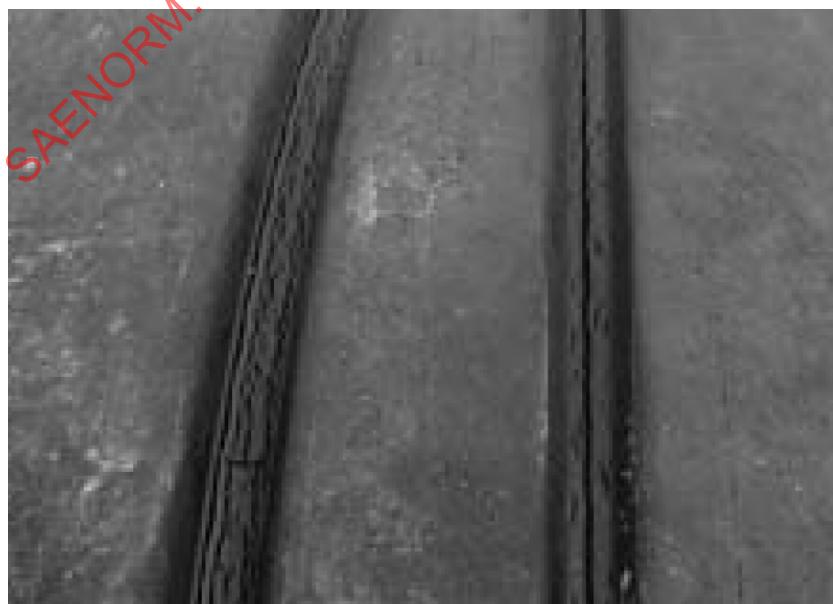
FIGURE 14 - GROOVE CRACKING

Groove cracking may result from ozone attack of the rubber or excessive flexing of the groove bottoms as a result of insufficient inflation of the tire. These cracks occur along the bottom of tread grooves (Figure 14).

- groove cracking exposes the reinforcing ply (bias tire) or the protector ply (radial tire) for more than 0.25 inch (6.35 mm) circumferentially in length.
- groove cracking has led to undercutting of the adjacent rib by more than 0.25 inch (6.35 mm).

<u>Groove Cracking</u>	Groove cracking may result from ozone attack of the rubber or excessive flexing of the groove bottoms as a result of insufficient inflation of the tire. These cracks occur along the bottom of tread grooves (Figure 14).	The tire should be removed immediately from the aircraft if: <ul style="list-style-type: none"> groove cracking exposes the reinforcing ply (bias tire) or the protector ply (radial tire) for more than 0.25 inch (6.35 mm) circumferentially in length. groove cracking has led to undercutting of the adjacent rib by more than 0.25 inch (6.35 mm).
<u>Rib Undercutting</u>	Rib undercutting can be an extension of groove cracking progressing under a tread rib or develop as a break in the groove wall extending under the rib. This can lead to tread chunking, peeled rib, or thrown tread (Figure 15).	The tire should be removed immediately from the aircraft if undercutting extends more than 0.25 inch (6.35 mm) under the tread rib.

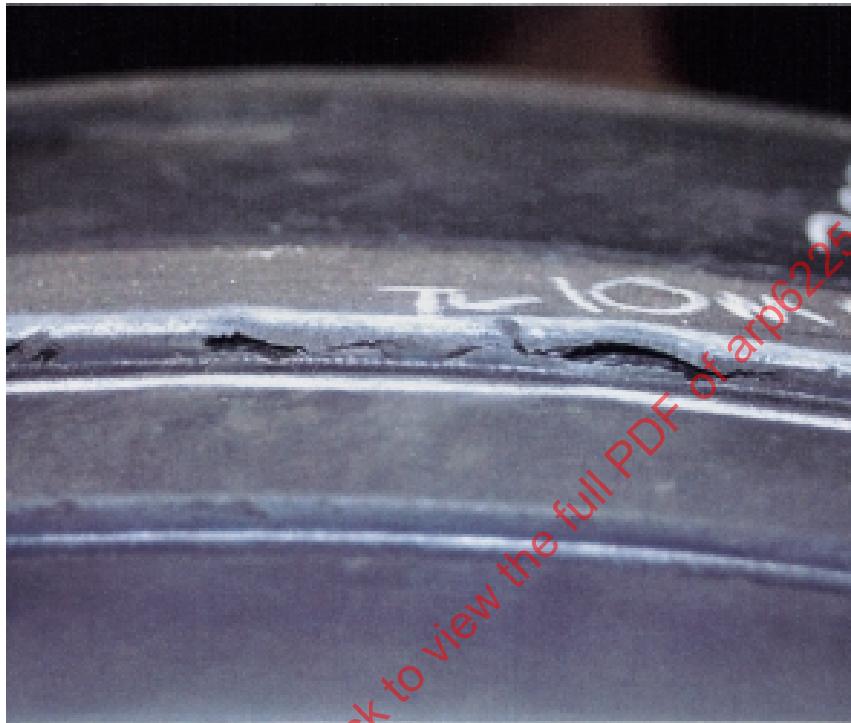
FIGURE 15 - RIB UNDERCUTTING

Rib undercutting can be an extension of groove cracking progressing under a tread rib or develop as a break in the groove wall extending under the rib. This can lead to tread chunking, peeled rib, or thrown tread (Figure 15).

REMOVAL LIMIT: The tire should be removed immediately from the aircraft if undercutting extends more than 0.25 inch (6.35 mm) under the tread rib.

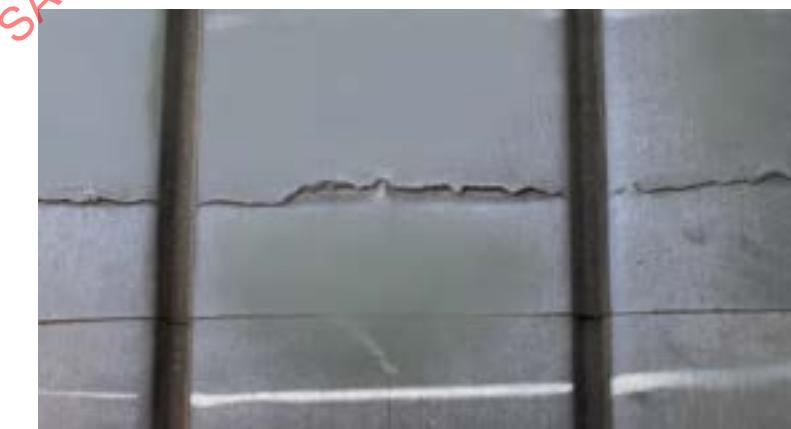
FIGURE 16 - OPEN TREAD SPLICE

An open tread splice is a crack in the tread rubber where the manufacturing joint or splice separates in a radial direction across the tread ribs (Figure 16).

REMOVAL LIMIT: The tire having this defect should be removed immediately from the aircraft.

<u>Open Tread Splice</u>	An open tread splice is a crack in the tread rubber where the manufacturing joint or splice separates in a radial direction across the tread ribs (Figure 16).	The tire having this defect should be removed immediately from the aircraft.
<u>Rib Tearing</u>	Rib tearing occurs when the tire is subjected to excessive side force during landing or taxiing (Figure 17).	The tire should be removed immediately from the aircraft if cords are exposed for more than 1.0 square inch (6.45 cm^2) or the damage extends the full width of the tread rib.
